# Monk Fryston and Hillam Sustainability Project

*Update no 4 April 2021*

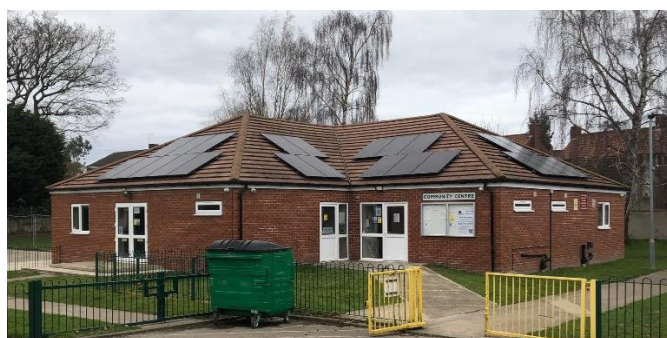
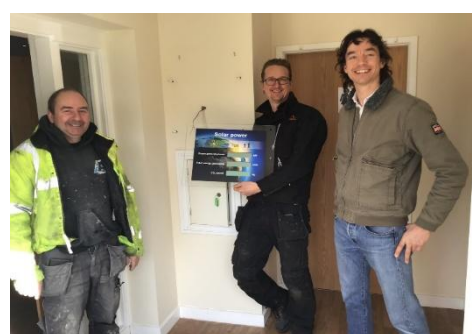
Our project and the Community Association took a big step forward on Friday 5<sup>th</sup> March when the 24 Solar PV panels were installed, started generating electricity and what's more important were connected to the national grid.

During the rest of March over 550 kWh of electricity were generated being more than enough to offset the building's own consumption albeit not always at the right time of day. A 10 kWh storage battery is still to be installed which will help balance the supply and demand. The main thing to do now is to sort out some mysterious power usage surges which have come to light via the real-time monitoring system. Since, this smart meter graph was down-loaded we have been assessing the cause of these regular spikes. What is clear is that we have a regular underlying 24 hour a day usage for Fire exit signs, CCTV security, wifi and fridges but the spikes are a mystery. However, better that we investigate than live in ignorance – so an investigation is underway. Who said smart meters were a waste of time!

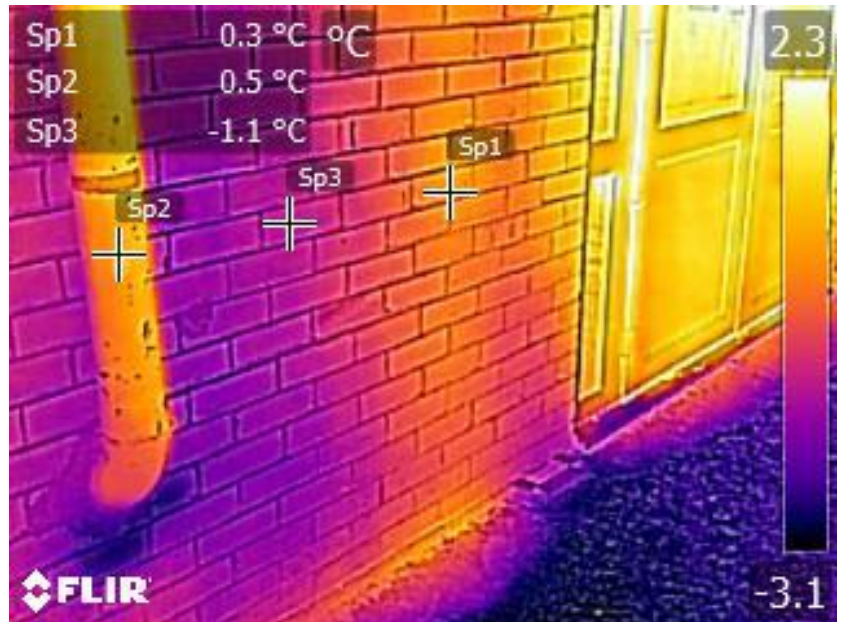
The picture on the right is taken outside the north wall between the sheds and the Community Centre. When we first saw these pictures, we just couldn't remember what the pipe was!

Later, we identified it as the soil vent pipe (SVP) from the Community Centre former gent's toilet. It was much warmer than the surrounding brick wall and radiating heat to the outside. It appears that in our rush to redevelop the Community Centre in just 6 weeks in 2014 we must have blanked it off with plasterboard but didn't remove or thermally insulate it. The underfloor heating pipe which showed up as a yellow column on the inside picture can be clearly seen as well as the low thermal performance of the exit doors glowing yellow.
